SUBJECT: ON-SCENE COORDINATOR'S REPORT - Removal Action at the Toledo Plate and Window Glass Site, Toledo, Lucas County, Ohio (Site ID #RA)

ON-SCENE COORDINATOR'S REPORT
CERCLA REMOVAL ACTION
TOLEDO PLATE AND WINDOW GLASS SITE
TOLEDO, OHIO

SITE ID # RA

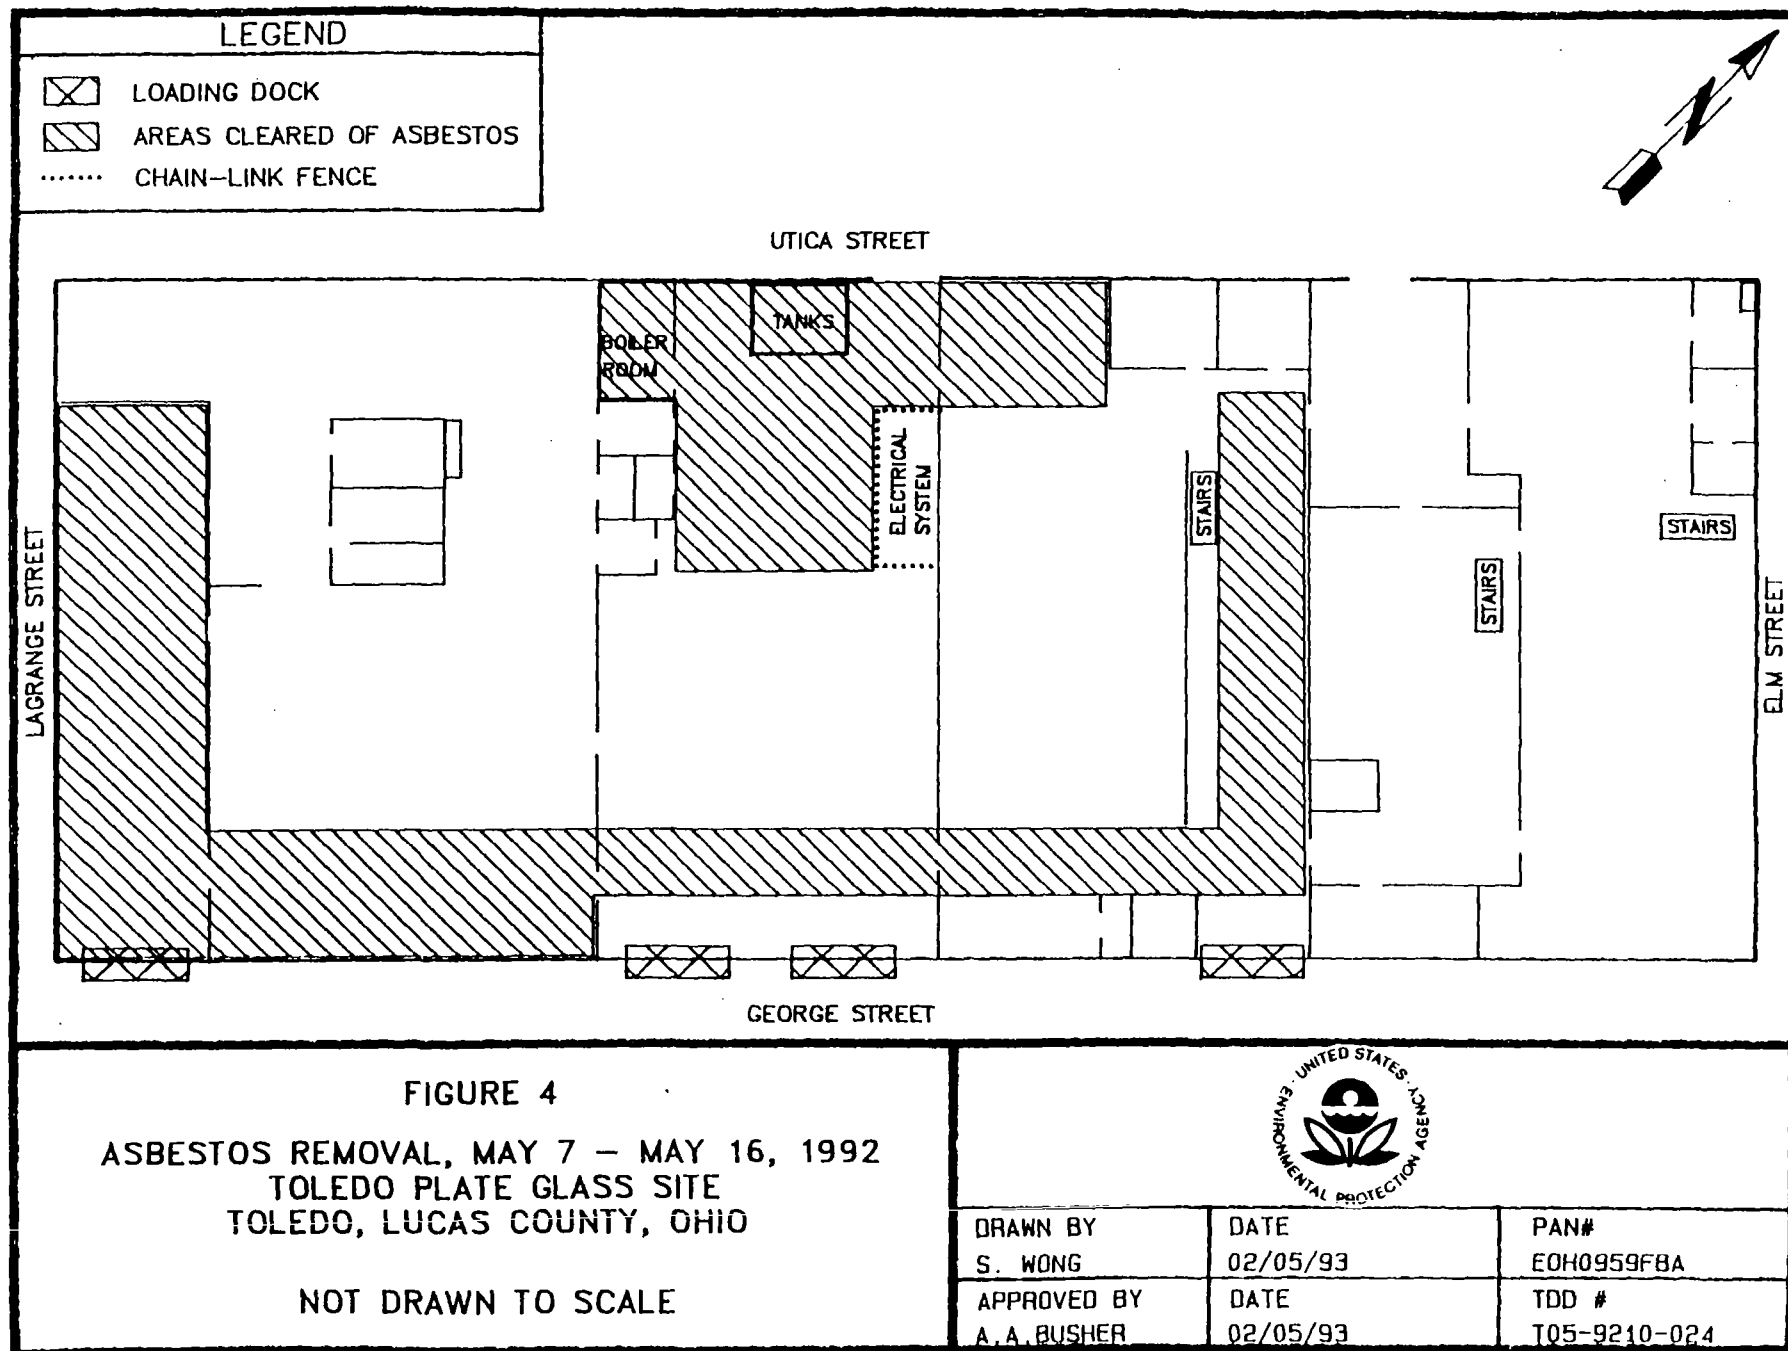
The tank enclosure of TPWG (Figure 4) was designated for immediate abatement activity due to the severely deteriorated condition of the asbestos in that area. The garage area (Figure 4) was also designated for immediate cleanup because it was to be used as the drum staging area for the chemical wastes to be collected and removed from the TPWG facility.

The abatement crew was mobilized to site on May 7, 1992. They were tasked to: (1) conduct asbestos abatement activities around the first floor tank enclosure on the west side of the TPWG building; (2) clear all visible debris from the garage area located at the south end of the building; (3) repair pipe insulation along a designated corridor using re-wettable cloth; and (4) clear all visible ACM from a 100-square-foot area, bag it, dispose of it in a rolloff box, and then spray the designated area with encapsulant.

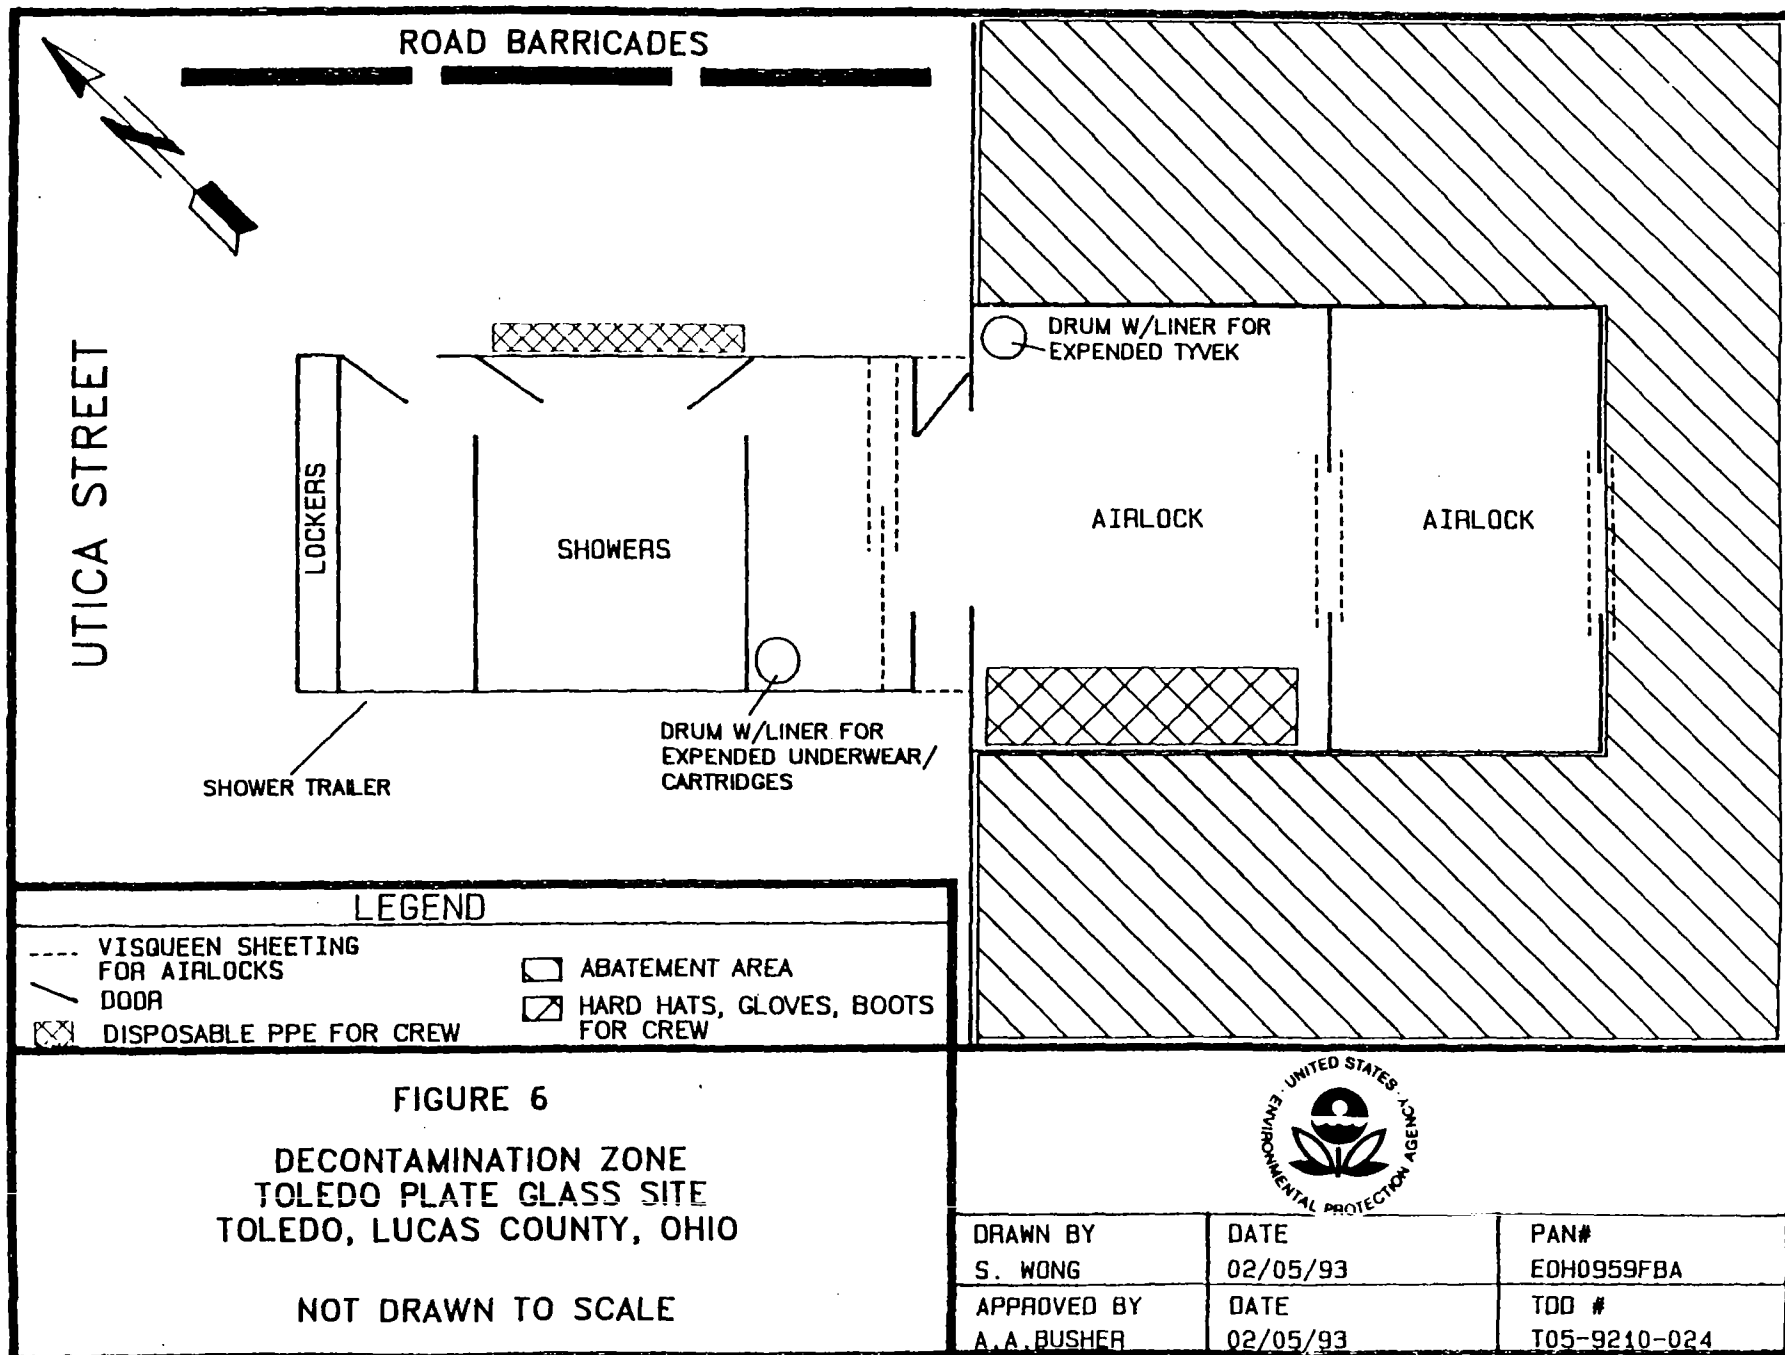
The decontamination zone was inspected by OSC El-Zein and modified several times at his request. OSC El-Zein directed the ERCS to make adjustments to accommodate the high volume of personnel involved in the cleanup and to ensure that essential equipment and supplies were easily accessible to personnel. Final adjustments to the zone were made on September 18, 1992. Figure 6 is a sketch of the decontamination zone.
